HISTORIC STRUCTURE REPORT  
VOLUME I

**CASA GRANDE**  
New Almaden, California

**COUNTY OF SANTA CLARA  
ENVIRONMENTAL RESOURCES AGENCY  
PARKS AND RECREATION DEPARTMENT**

March, 2000

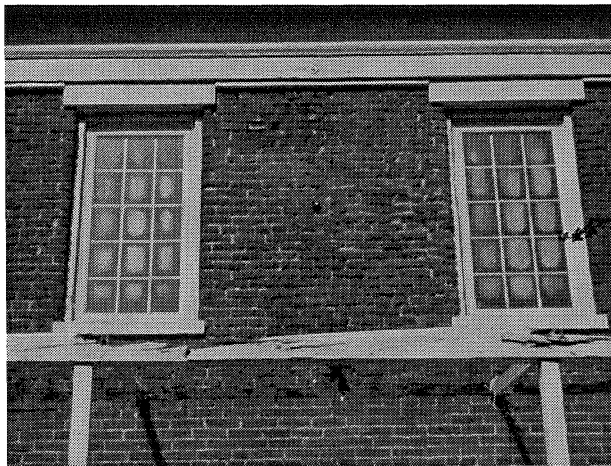
*Deteriorated Brick at East Facade*

The exterior walls of Casa Grande are constructed of red brick. These walls were once covered by a coat of plaster scored in an ashlar pattern to imitate stone. To continue the illusion that the building was constructed of stone, the original plaster was painted with a whitewash that was mixed with fine sand. The plaster coating was removed in two stages. First the upper floor facades in the 1960s and later the mid and lower level facades in the 1980s. In general, the exterior brick is in good to fair condition considering it is nearly 150 years old. This is due to the fact that the brick was covered with plaster most of this time. At some point, perhaps as part of the plaster removal, the exterior brick surfaces were sandblasted. This procedure and other removal processes such as chipping and grinding were also used to remove the original plaster. These abrasive removal processes created a condition that has led to the accelerated deterioration in some of the bricks in the more exposed areas.

The brick piers that support the verandas show considerable deterioration (of the brick and mortar) due to water intrusion. This is seen mostly at the base of the piers where water has “wicked” up the pier from ground moisture or standing water on the concrete decks, etc. A great deal of deterioration may be seen under the front veranda where the grade level has been raised. Here, a portion of the piers and walls retain soil and underground moisture has penetrated the wall and caused considerable damage to the historic material.

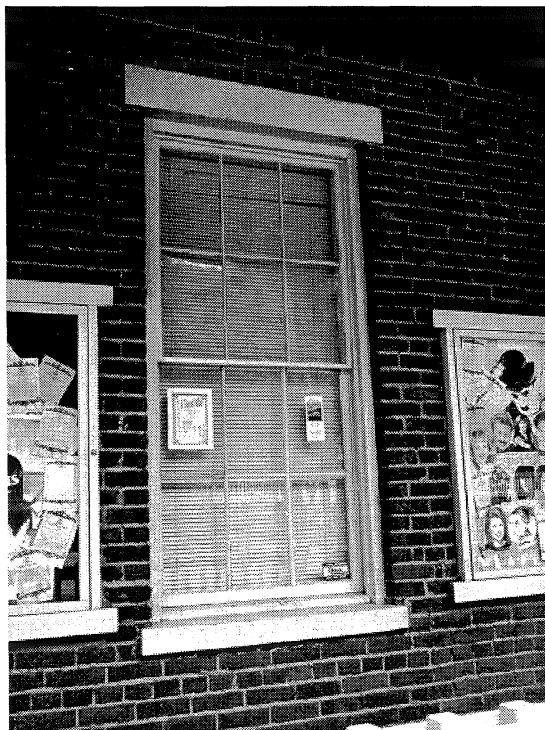
*Original Window*

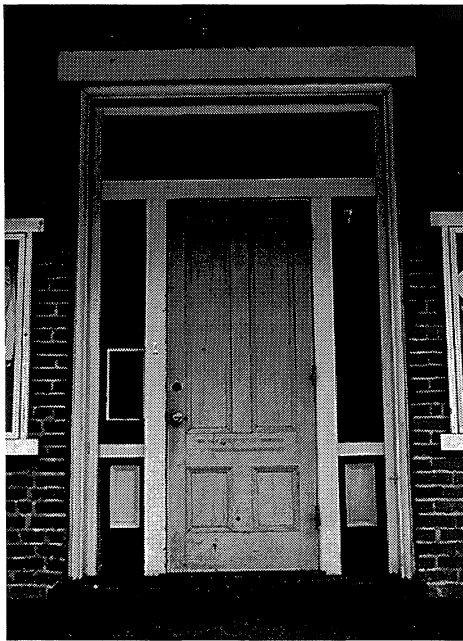
During our review of the building we found that only the rear and front hallway doors appear to be original or old enough to be considered historically significant. Both of these doors are “style and rail” type panel doors constructed with mortise and tendon joints. The hardware on these doors has been altered many times as evidenced by many patches on the jamb rails. The doors are in working order but in poor to bad condition and should be completely restored.

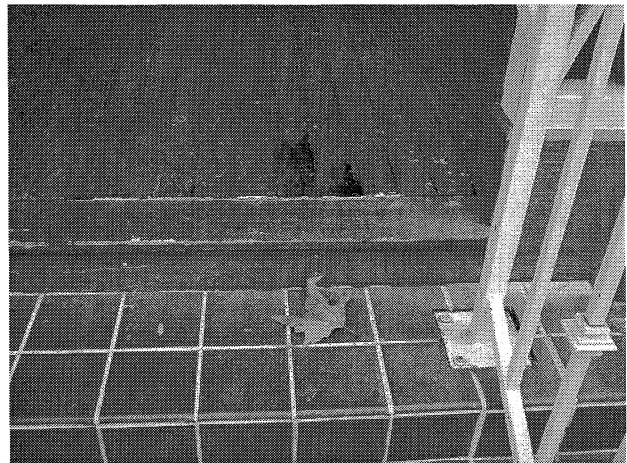
between each column. The floor is constructed of tongue and groove wood decking spanning the width of the veranda and is painted. The flooring is not original, but is quite old. There is a gap in the veranda flooring at the juncture of the wall where the original wall plaster was removed in the 1980s. Through this gap another tongue and groove flooring material can be seen. The area of flooring at the main entry stair is badly deteriorated and could fail causing injury. This area of flooring should be repaired immediately with new tongue and groove material that matches the existing.

*Veranda Floor*

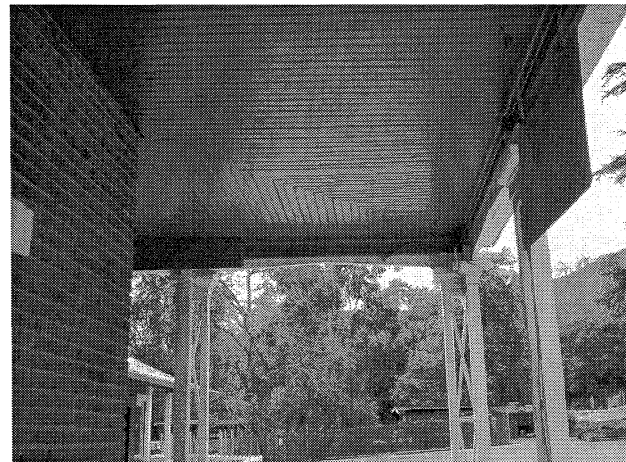
The ceiling of the veranda is constructed of tongue and groove “bead board”. Most ceiling material looks to be in good condition with the exception of the area at the front door of the “Opry” where the ceiling sags. The source of this sag should be investigated and the material removed. Once this is done, the ceiling boards can be restored to their proper condition.

*Veranda Ceiling*

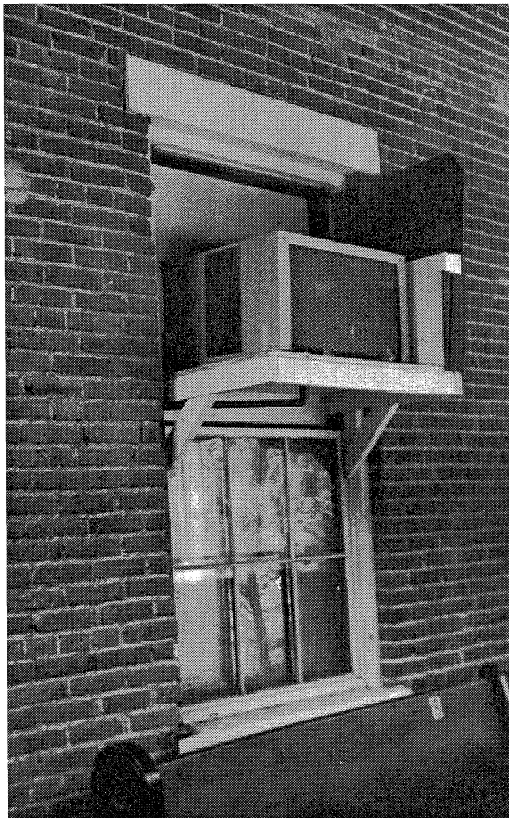
There are a number of areas where the existing HVAC systems do not meet current code standards. Most of these involve inadequate ventilation of the spaces, or in the case of the lower floor toilet rooms, no ventilation at all. A more detailed analysis of the HVAC systems is provided in the Existing Conditions Report in the Supplemental.

*AC Unit at Stars Dressing Room Window* 2000

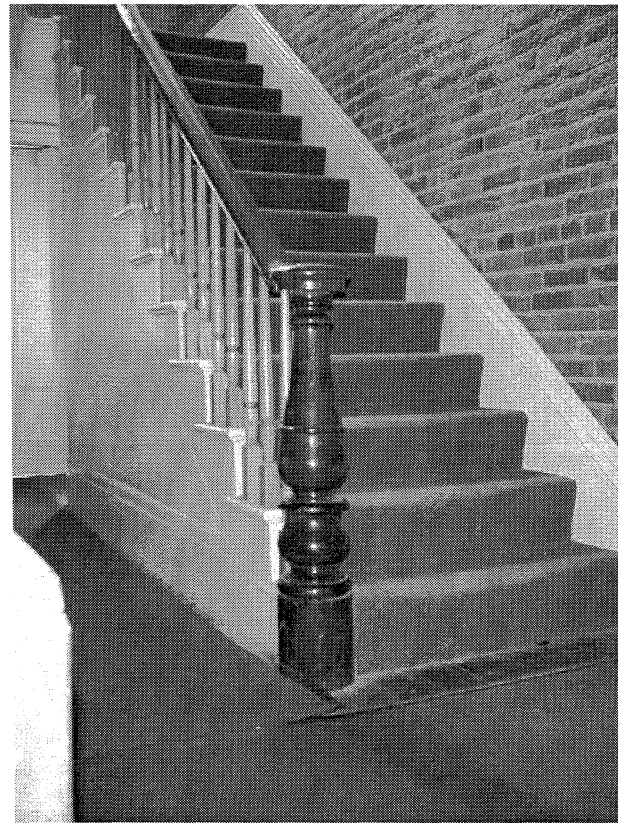
The height of the hand and guardrails of the main interior stair do not meet current code. Unlike the front veranda railing, the main stair rails are either original to the building or very old and are considered a significant historical element. In this area, the Historic Architect could invoke the SHBC to keep the railing heights the same. However, since the issue is one of public safety, the County and the Historic Architect will entertain possible solutions that could add safety while not detracting from the historic character of the stair.

Main Stair Railing

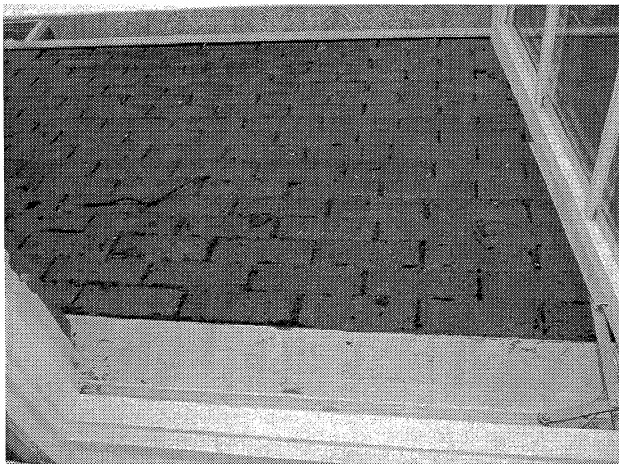
The existing roofs of the building are a hodge-podge of asphalt shingles and rolled roofing. They show many signs of recent patching and there is evidence of water intrusion in numerous areas of the interior.

Veranda Roof Shingles

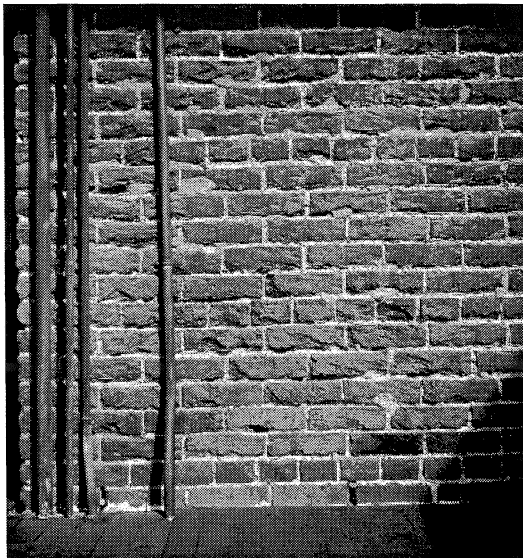
To preserve the historic brick of the Casa Grande, the ongoing deterioration must be deterred. The three methods researched by the design team are: 1) coat the brick with an opaque breathable masonry paint; 2) coat the brick with a clear breathable masonry coating; or 3) re-plaster the building.

*Roughened Brick* 2000

It is the opinion of the Design Team that painting the building with an opaque breathable coating is not appropriate since the brick of the building had never been painted. Therefore this treatment would not meet the Secretary of the Interior’s Standards for Restoration of Historic Buildings. Also, the coating would need to be re-applied every few years and would add a considerable maintenance life cycle cost.

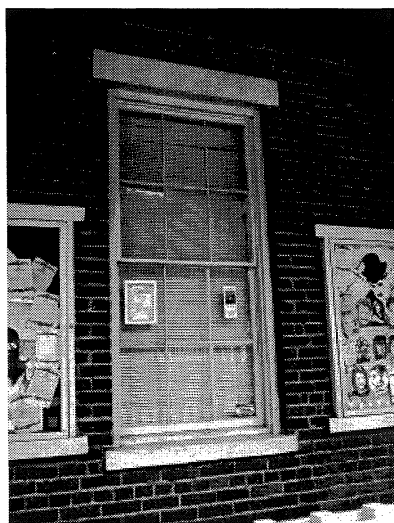
All of the original windows are in need of repair or general maintenance. During the restoration of the building it is recommended that each original window is to be restored to its original configuration and put into working order. The restoration plans call for the replacement of broken or missing glass with single plate glass, along with replacement of sash cords and weights. Missing sashes will be replaced with new sashes manufactured to match the original.

*Original Window* 2000

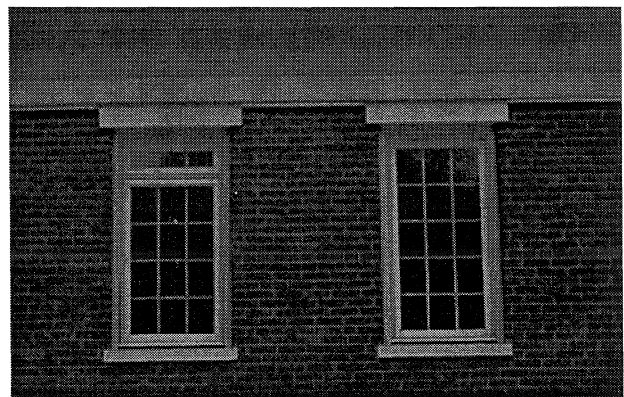
*Upper Floor Replacement Windows* 2000

The restoration plans call for these windows to be removed and new double hung wood windows manufactured to match the original wood windows installed. At the in-filled window opening on the upper floor, the brick in-fill material will be removed and a new double hung wood window installed.
