HISTORIC STRUCTURE REPORT
VOLUME II

CASA GRANDE
New Almaden, California

Prepared for

**COUNTY OF SANTA CLARA
ENVIRONMENTAL RESOURCES AGENCY
PARKS AND RECREATION DEPARTMENT**

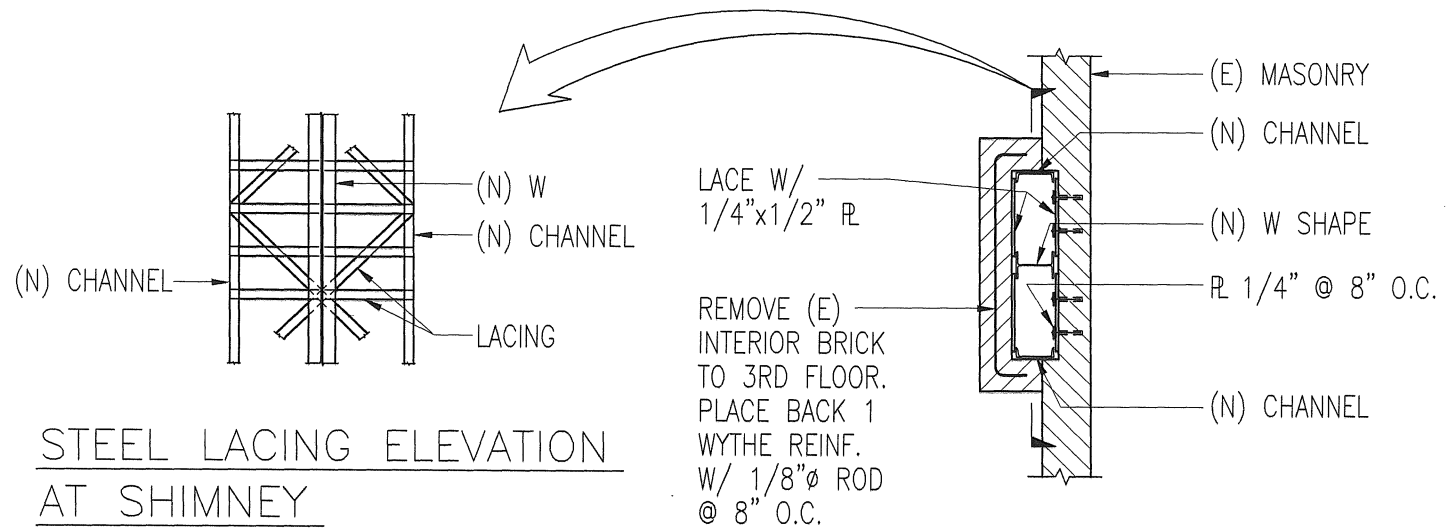
STEEL LACING ELEVATION
AT SHIMNEY

1. The chimney bracing appears to be so flexible that it may twist and move so much that the chimney may fail. The connection to the roof framing is also questionable.
2. The museum chimney bracing is placed in such a manner that it may actually induce twisting of the chimney and cause a failure.

We have provided a new means of supporting the masonry chimneys in our conceptual drawings. It has been found that unreinforced masonry chimneys are usually the first element to fail in an earthquake and we strongly recommend that the chimneys be supported properly.
