HISTORIC STRUCTURE REPORT  
VOLUME I

**CASA GRANDE**  
New Almaden, California

**COUNTY OF SANTA CLARA  
ENVIRONMENTAL RESOURCES AGENCY  
PARKS AND RECREATION DEPARTMENT**

March, 2000

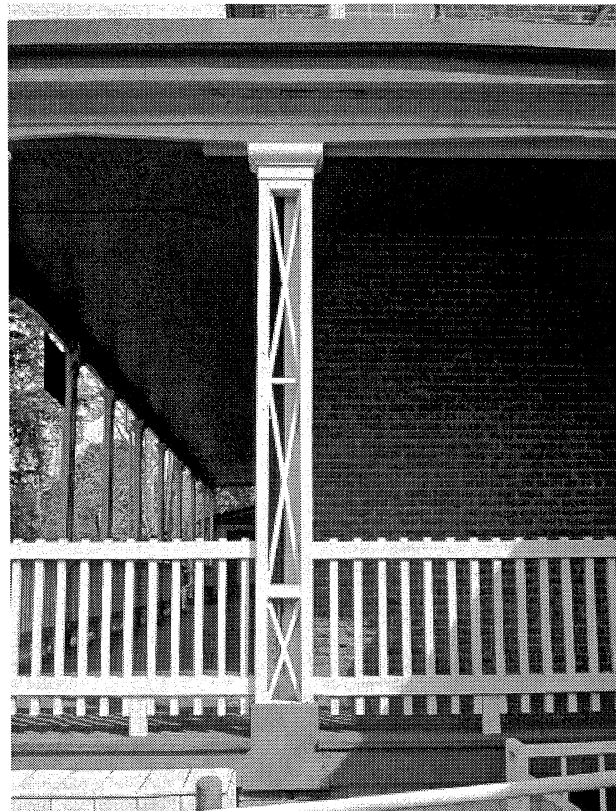
Veranda Column 2000

The front veranda of the Casa Grande is a remnant of the veranda that originally continued around all sides of the building. The veranda on the north side was removed when the dance floor was enclosed. The rear veranda was intact until the early 1990s. The front veranda is supported by columns consisting of two vertical 2" x 4" posts spaced approximately 12" and connected by 2" x 4" diagonals that zigzag the length of the column creating a light lacy element on the facade. The individual column elements are unified at the base and head trim. Most of the column elements look as if they have been replaced over the years with few, if any, original columns remaining. The columns are in good condition.

between each column. The floor is constructed of tongue and groove wood decking spanning the width of the veranda and is painted. The flooring is not original, but is quite old. There is a gap in the veranda flooring at the juncture of the wall where the original wall plaster was removed in the 1980s. Through this gap another tongue and groove flooring material can be seen. The area of flooring at the main entry stair is badly deteriorated and could fail causing injury. This area of flooring should be repaired immediately with new tongue and groove material that matches the existing.

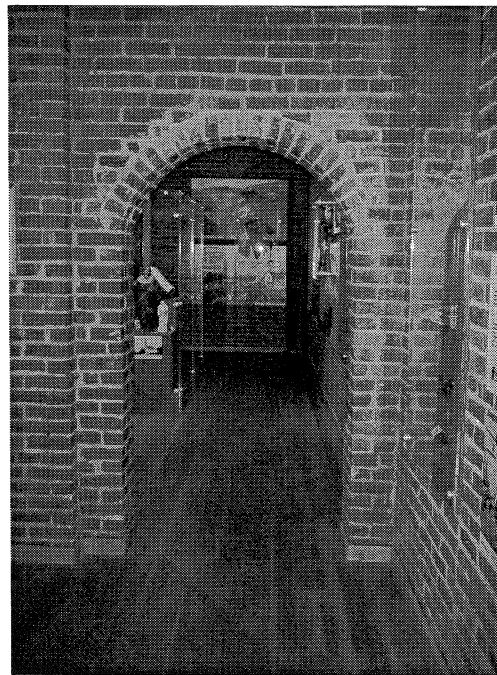
*New Flooring at Mining Museum*

The floor material of the Main Hall and possibly the Opry Dressing Room are original wood plank flooring. The museum remodel and the seismic upgrading performed in 1997 required the removal of the original flooring in the second and third floors where seismic strapping was required. A new soft wood floor was installed in the main museum area to match, as closely as possible, the original flooring material. The new floor is unstained, oiled and in good condition. The original flooring in the Main Hall shows a lot of wear, but is in good to fair condition. Other areas of the second and third floors have either carpet or vinyl flooring that was recently installed in the museum remodel or seismic upgrade and are in good condition.

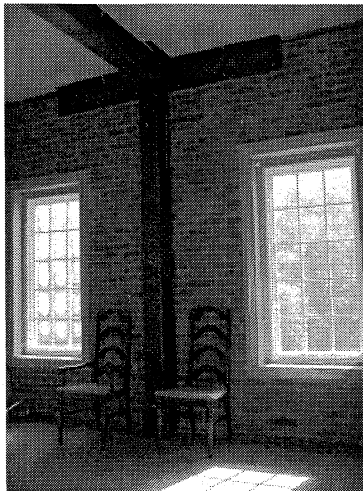
*Steel Frame at Upper Floor* 2000

removed throughout most of the building. Wall to floor ties and plywood diaphragms were added. Two steel moment frames were added on the third floor. The columns of the moment frames are located on the third floor, seated on the top of the 2<sup>nd</sup> floor interior brick walls, to the top of the ceiling joist. There are also angle brackets at the top of the 3<sup>rd</sup> floor perimeter brick walls spaced at approximately 32" to 48" o.c. There are several questions regarding the upgrade and it may be prudent to examine the effectiveness of the seismic upgrade.

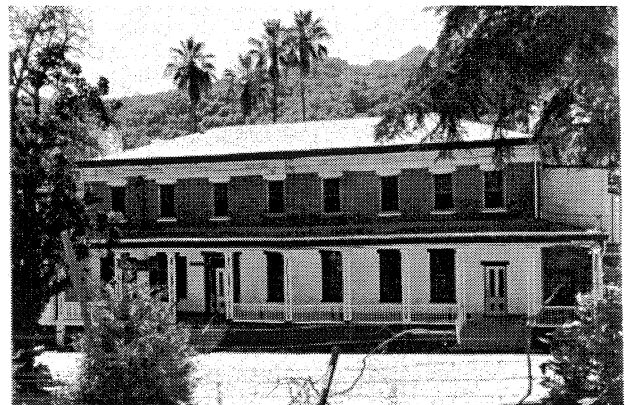
*Casa Grande with Plaster Removed from Upper Floor* Circa 1970

In the case of Casa Grande, the brick surfaces were first exposed in the 1960’s when the plaster started to deteriorate and fall off the building. In the areas where the plaster was removed in the ‘60’s, the brick has started to deteriorate. The most deteriorated area is on the east (rear) facade of the upper floor where large sections of brick will be lost, if the deterioration is not stopped.

In 1985 the remainder of the plaster was removed from the lower floor facades. Since most of this plaster was protected from the elements by the veranda roofs it was not badly deteriorated and was

Plastering the building again is appropriate if the plaster matches the original plaster in material, texture and detail. Sufficient historic photographic evidence of the building is available to ascertain the areas of plaster and the score pattern. We have also found two areas of original plaster on the north wall of the main floor on either side of the Opry House stage. From these sources, there is enough information to accurately reconstruct the plaster finish on the building. Our findings were submitted to the Western Region office of the National Park Service (the entity that administers the National Register of Historic Places). After review, they concurred with the design team recommendation that the replacement of the plaster on the exterior wall would not only be appropriate but would also be the preferred preservation technique to preserve the historic brick material. Therefore, we are proposing in our restoration plan that a new plaster coating be applied to all of the exterior masonry surfaces. The new plaster will be similar to the original in composition and will be scored and painted to match the original finish.

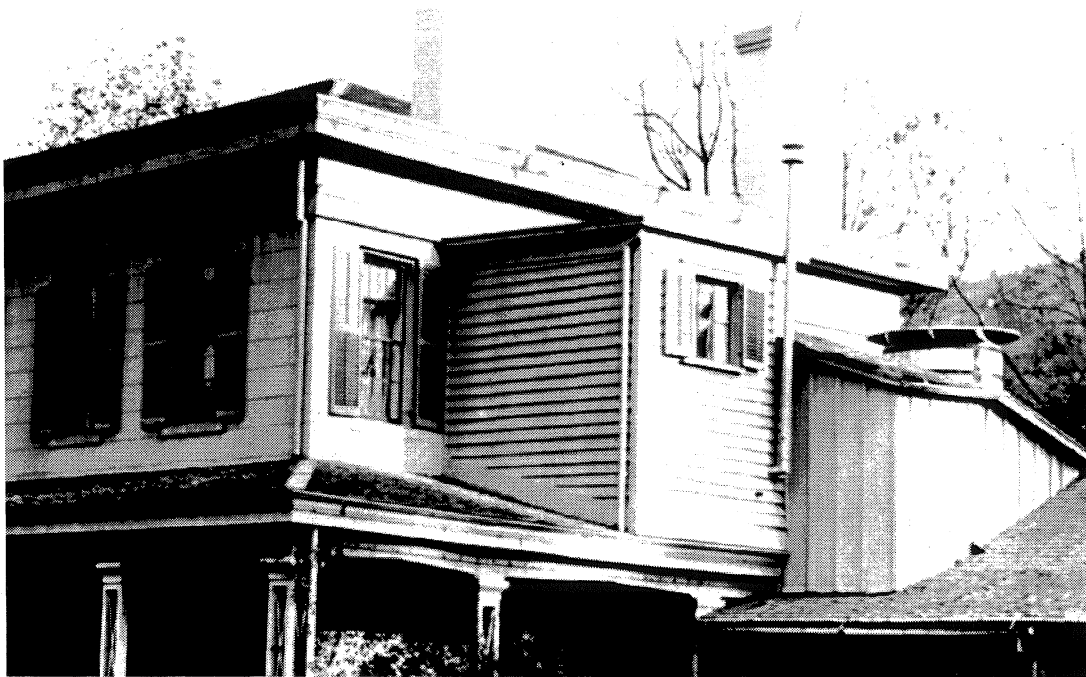
The only existing exterior wood clad walls are at the Opry House, the lower level bathroom additions and the rear museum additions on the lower and main floor levels. All of these areas are slated to be removed in the restoration plan for the reconstruction of the veranda. Historically, there had been wood siding on portions of the Casa Grande. Photos from the 1880's show a bathroom and stair enclosure on the south end of the upper level that were finished with wood siding. The bathroom section had horizontal siding where the stair enclosure had vertical board and batten siding. Photographs from as late as the early 1970's show these elements still intact.

*Detail of Plaster and Wood Siding*

Since the existing wood siding exists only on building elements that are proposed to be removed, there will be no restoration requirements. However, there is one new element of the design where wood siding is proposed. The new Stair/Elevator structure, which is designed to blend with the historic character of the

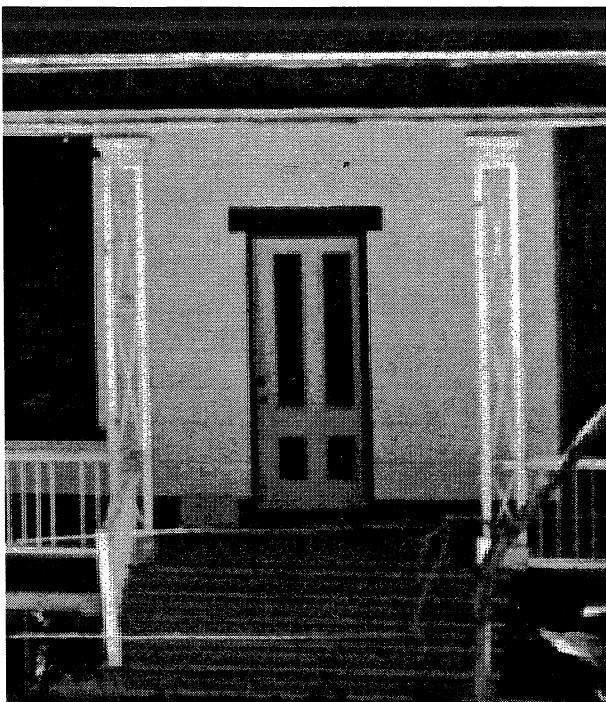
The two original wood doors at the front and rear hallway opening of the main floor are in poor condition. They have been fitted and re-fitted with hardware and patched many times.

*Original Wood Door*

The original doors will be removed and restored in a wood shop. They will need to be carefully taken apart and the individual styles, rails and panels refinished and missing or deteriorated tendons patched. Once re-assembled, the doors will be re-finished, fitted with new hardware and installed in their original locations.

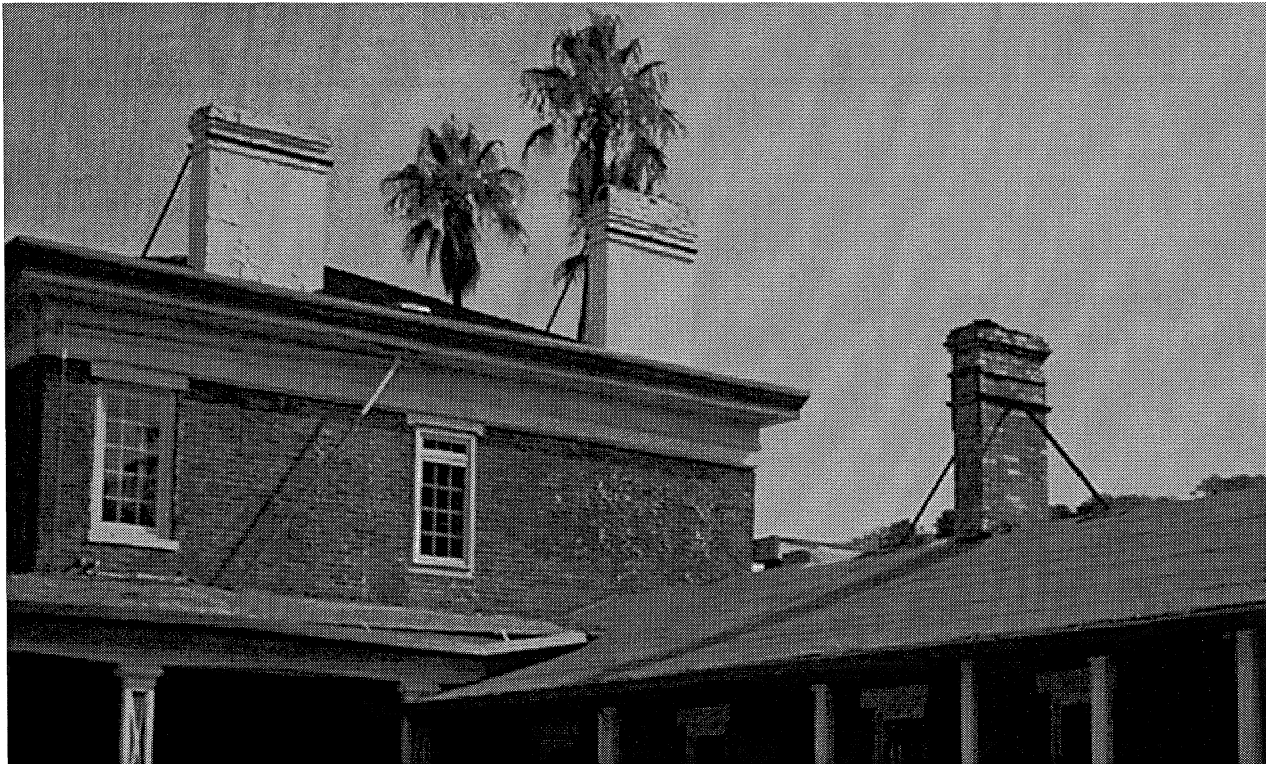
*Chimney Braces*

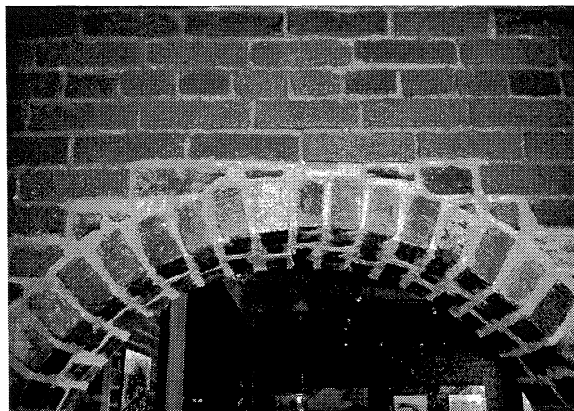
*Arch at Museum*

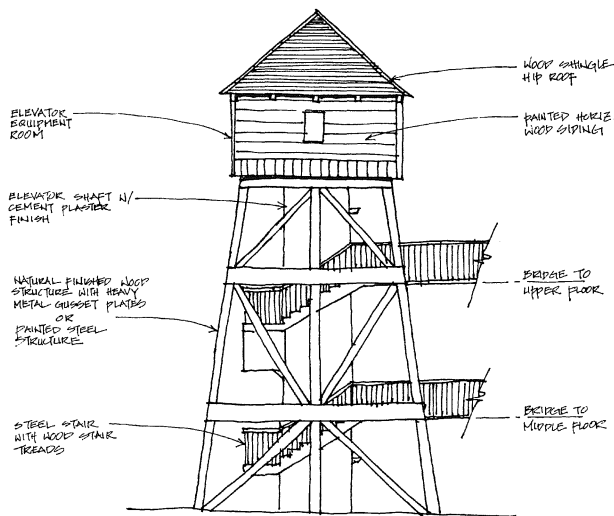
A new elevator/stair structure with a walkway as shown on the architectural schematic drawings is proposed. Because of the spans, height, and overturning issues, we feel that steel or concrete is the most appropriate structural system. We have designed the supporting braced structure in steel. Wood nailers may be attached for framing a wood deck and wood handrail system. Steel members also support the walkway between the main building and stair tower. The connection at the existing building and the walkway supporting beams provides bearing yet allows horizontal movement between the main building and the stair structure. This is accomplished by providing a Teflon slider at the building.

*Elevator/Stair Structure Design Sketch*
